Tonga Education Support Programme

School Infrastructure Survey 2006

Infrastructure Advisor for School Mapping Report

June 2006

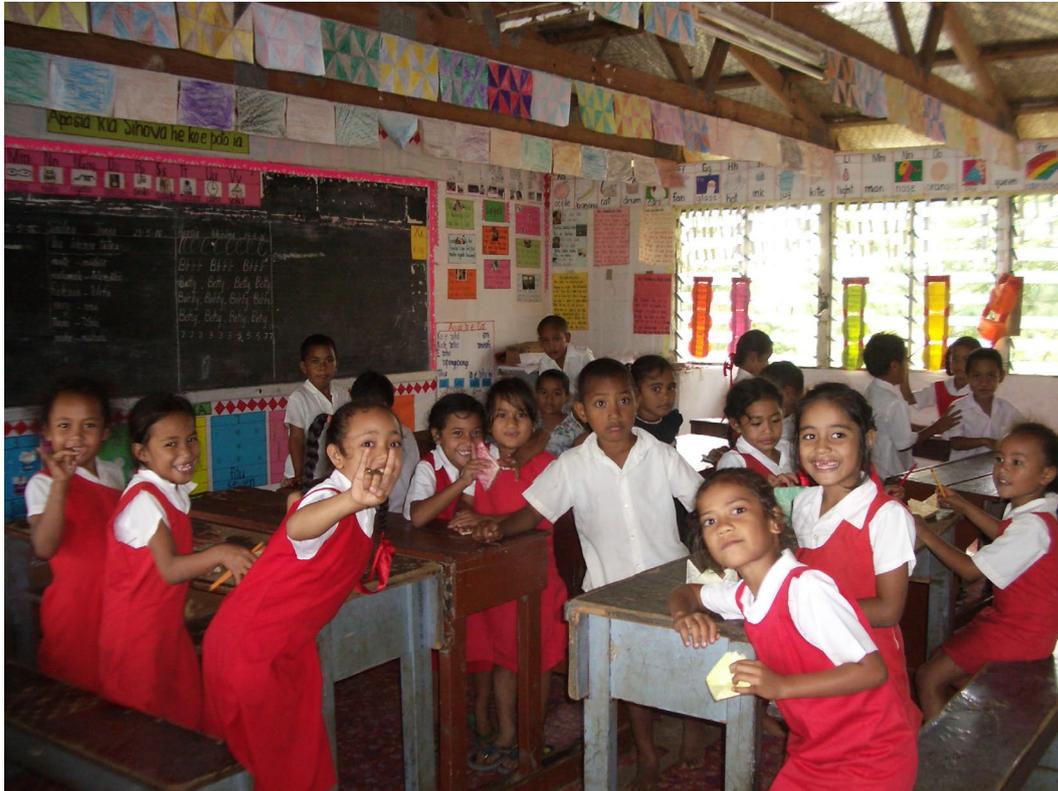
Plate 1: Classroom in Classroom Building 1

The building is quite well constructed but there are a number of problems. The construction of the roof trusses and the fixing of the purlins are quite inadequate as there is no bracing or any cyclone fixings whatever and the purlins are too far apart. The roof sheets are fixed with nails and not with cyclone screws and washers. The timber framing to the window walls is not adequately fixed to the up-stand block walls and the trusses are not properly secured to the timber framing. It was also not clear whether the block walls were reinforced or filled. The building also requires some repairs and maintenance: all door hardware requires replacement, some louvre blades require replacement and the building needs painting.

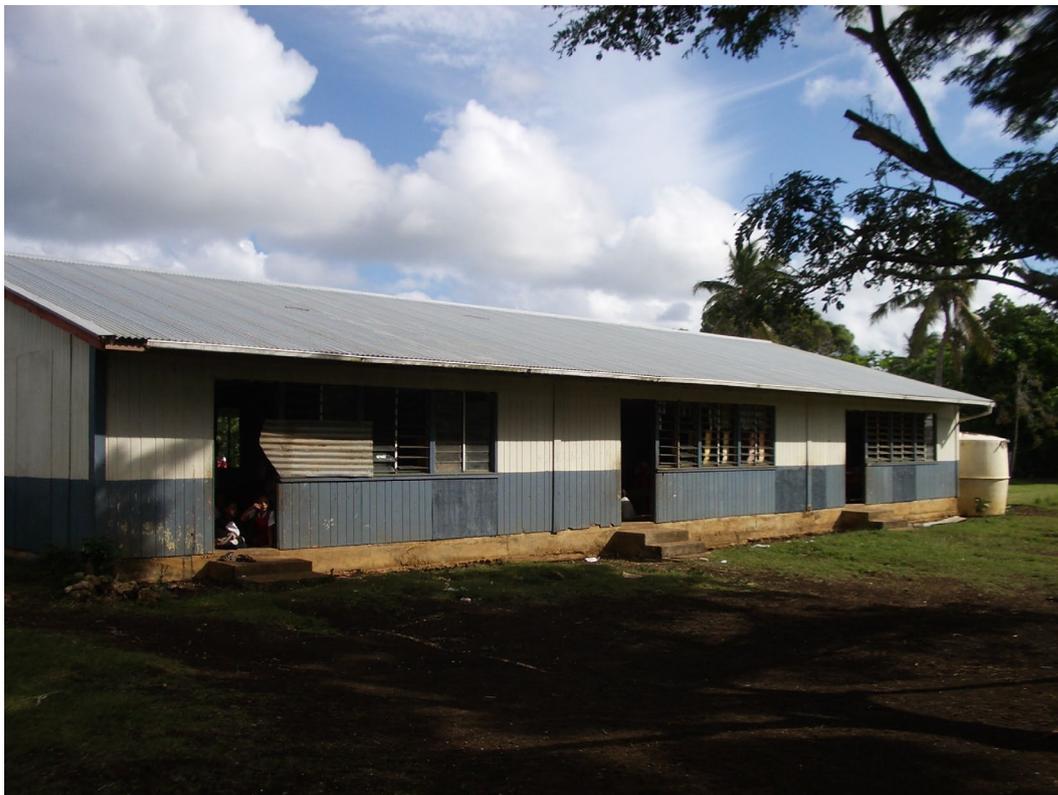
Plate 2: Classroom Building 2

The building seems to have been quite well constructed (apart from the roof) originally but is now in need of major repairs. The whole of the roof structure needs replacement (including the timber framing to the walls); taps to basins and louvres need replacement; some WCs need replacement; there are a number of leaks that require repair; doors need to be re-hung and the building needs painting. It would probably be more cost-effective to demolish the building and construct a new one.

Recommendations: The school requires additional facilities such as a store and an office for the principal and teachers in order that all classrooms can be used efficiently. The staff quarters should be demolished and replaced if necessary. The existing classrooms require a lot of work to bring them up to current standards in terms of cyclone resistance as well as general repairs and maintenance. The toilets require major works to the roof as well as repairs and maintenance and it might be more economic to replace them with new toilets.

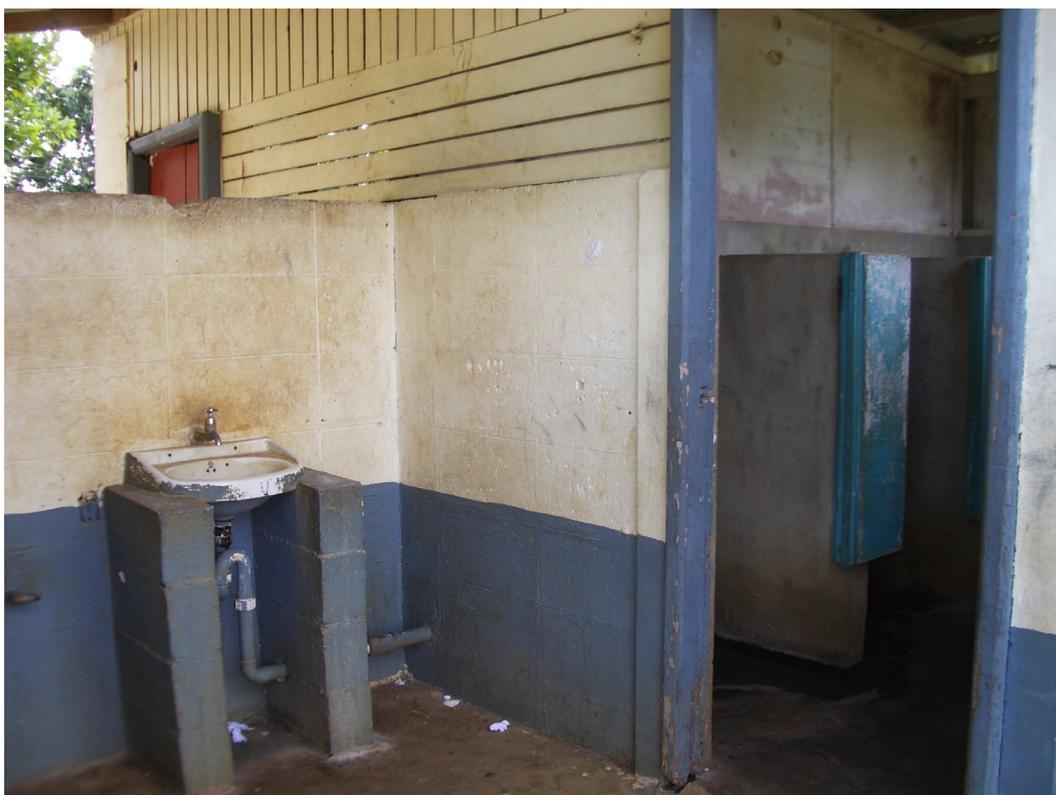
Plate 3: Toilet Building

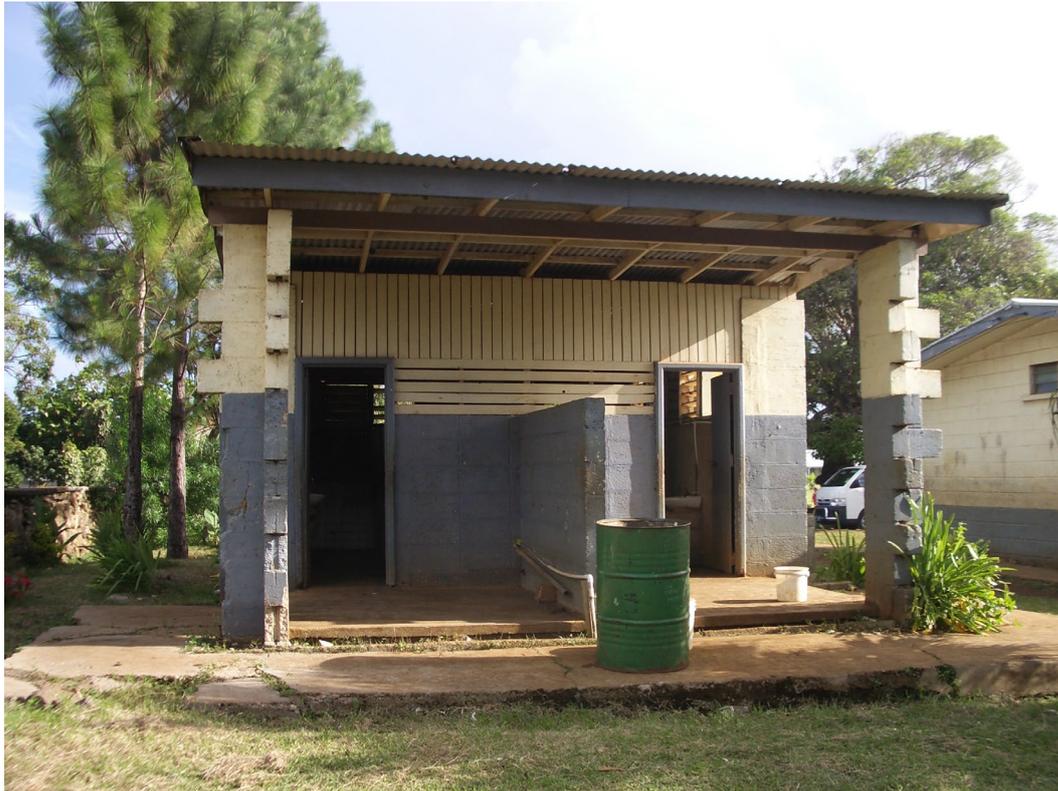
Plate 4: Toilet Building; note low pitched and poorly constructed roof

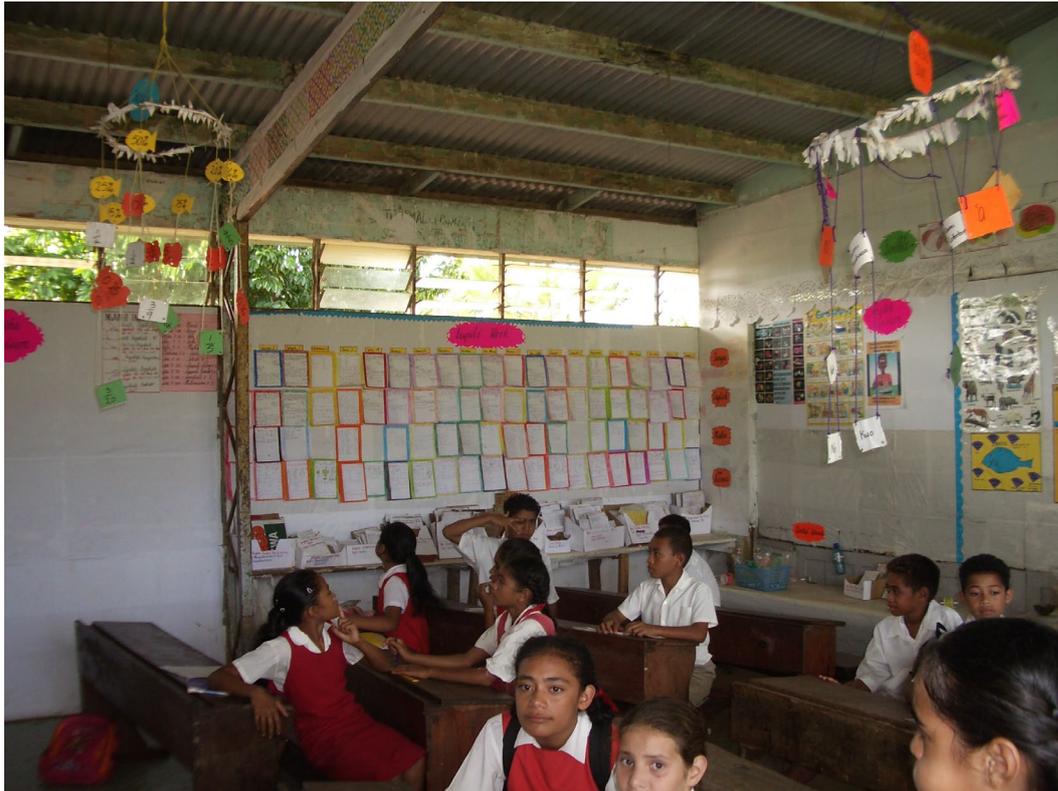
The building was originally quite well constructed but has had little maintenance and now has some major problems. It is again doubtful whether the roof structure meets the new building code as the purlins are probably too small and too widely spaced. The roof sheets are also fixed with nails not cyclone screws and washers. The louvres need maintenance and the eaves and verge boards are rotten in places and need replacement together with the gutters.

Plate 5: Classroom in Classroom Building 2; note wide spacing of purlins

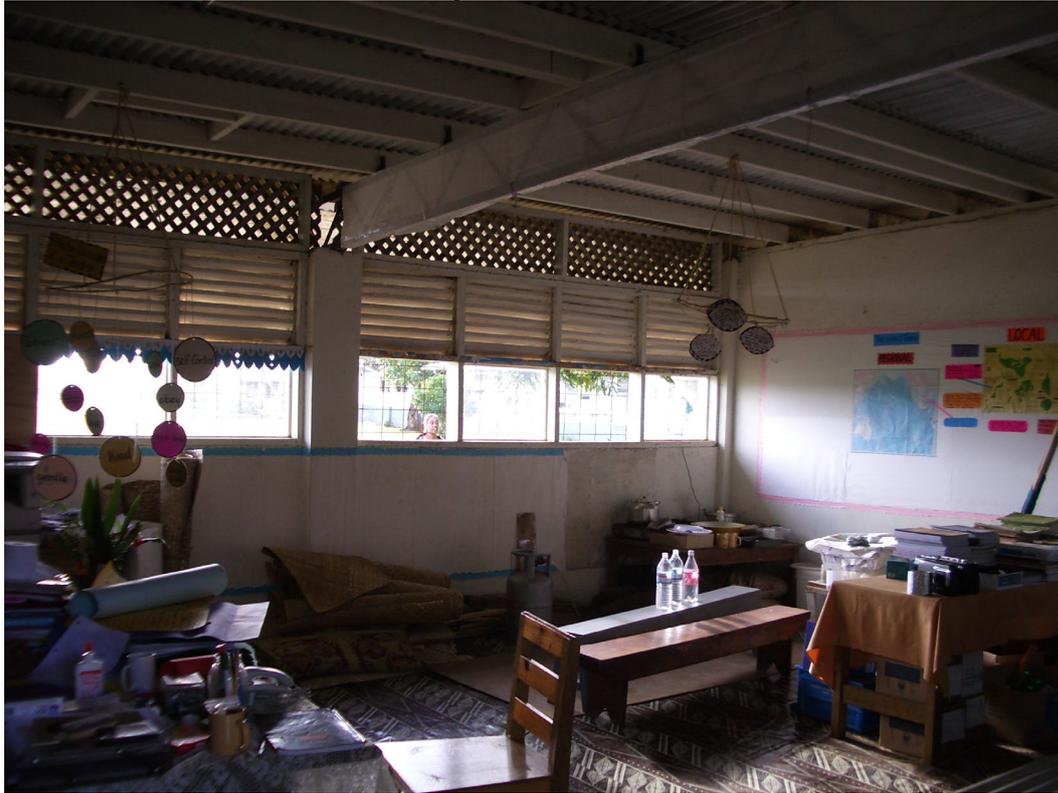
Plate 6: Classroom in Classroom Building 2 being used as an office; note wide spacing of purlins

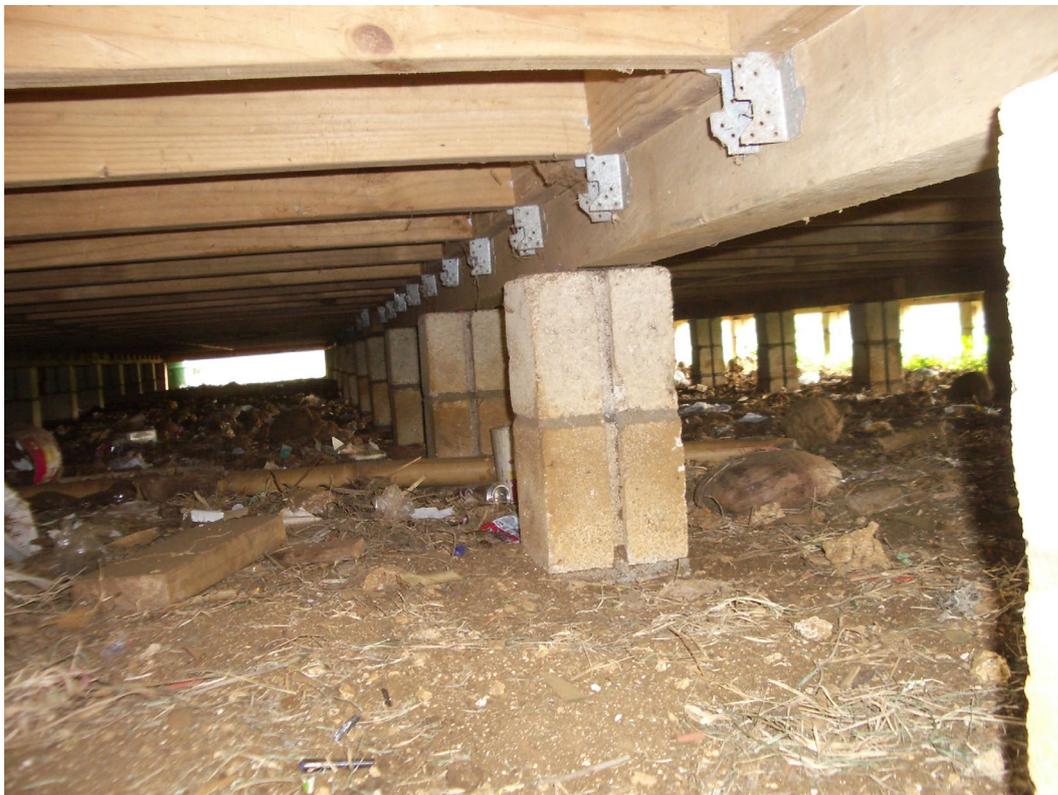
Plate 7: Foundation columns to Classroom Building 3 showing lack of bracing

Recommendations: The school requires additional facilities such as a store, an office for the principal and a staffroom in order that all classrooms can be used efficiently. The single classroom should be demolished and replaced and the two old toilet buildings should also be demolished and replaced as the current numbers of toilets are inadequate. The older classrooms require a lot of work to bring them up to current standards in terms of cyclone resistance as well as general repairs and maintenance and even the newer classrooms need cyclone screws and washers to the roofs and other works such as bracing of the foundations and possibly bracing of walls.

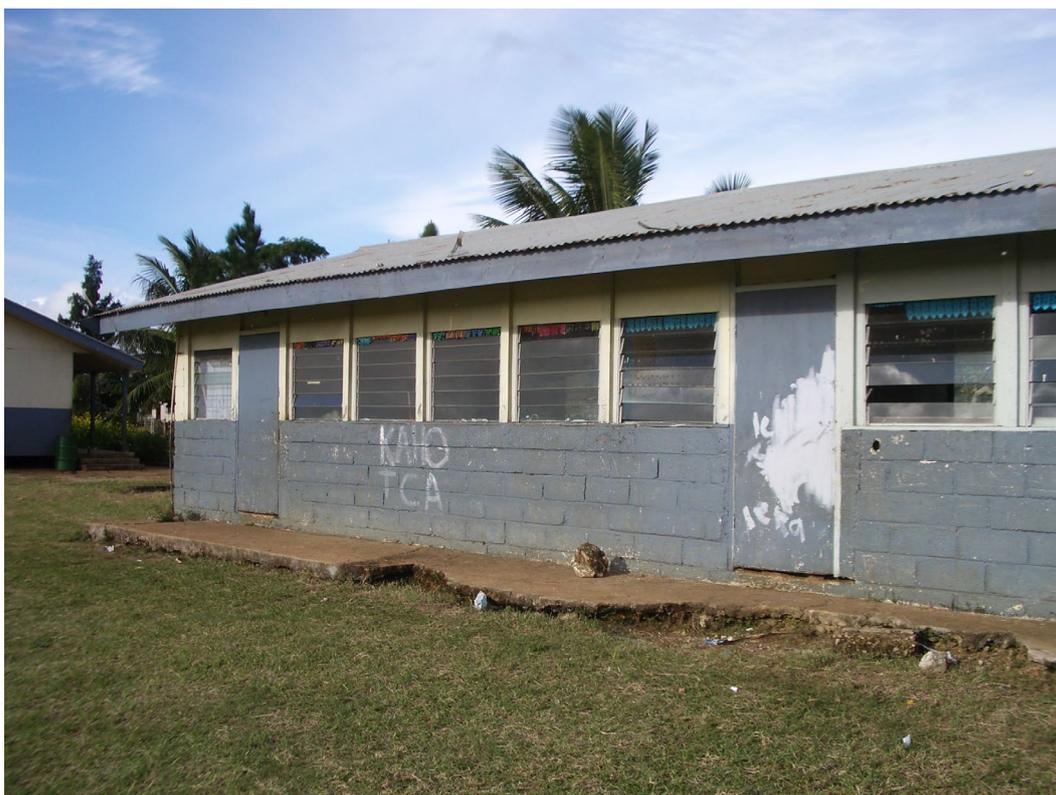
Plate 8: Classroom Building 4 showing poor condition and inadequate fixings to timber framing to walls

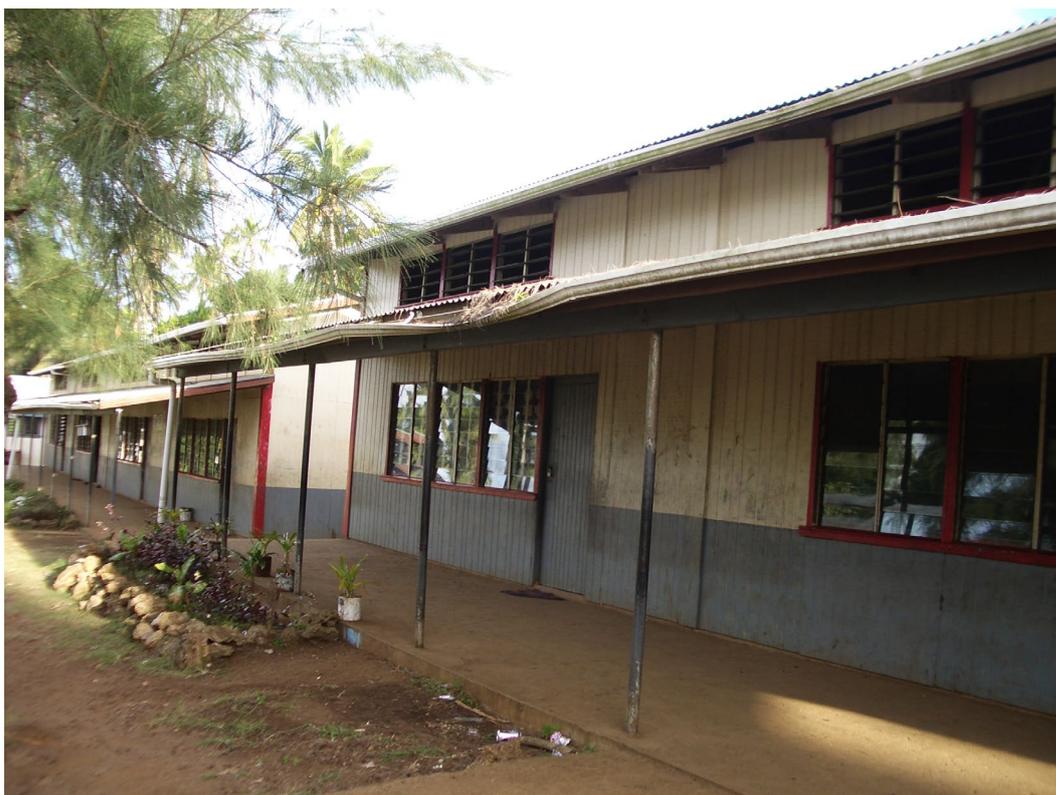
Plate 9: Classroom Building 2 and 1 showing generally poor condition

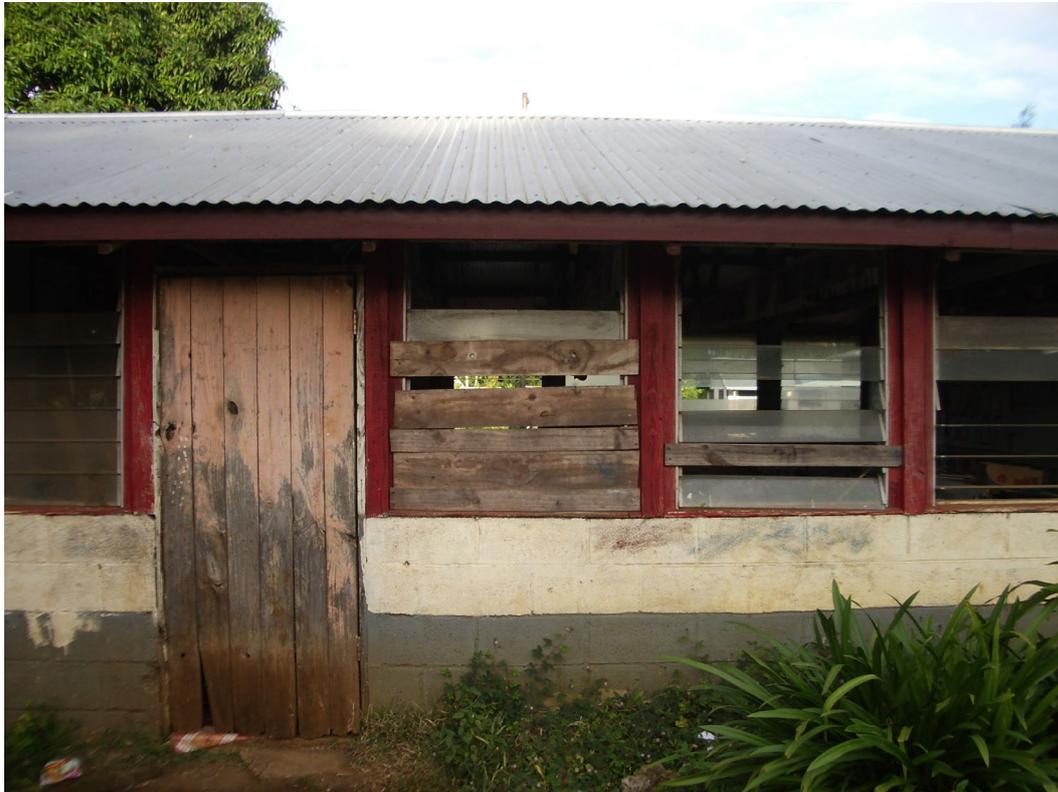
Plate 10: Classroom Building 4 showing generally poor condition and inadequate fixing of timber framing to walls.

The buildings were originally quite well constructed but are now in very poor condition and need major repairs. The roof sheet fixings and the roof purlins and trusses and the connections between the roof trusses and the timber framing on top of the walls will not meet the requirements of the new building code. The timber framing is also not adequately fixed to the top of the block walls. It would probably best therefore to completely re-build the roofs together with the timber wall framing. All doors and windows will also have to be replaced.

Recommendations: The existing toilets require repairs and maintenance and the school probably needs another toilet building to cope with the number of students. All buildings require a lot of work to them to bring them up to current standards in terms of cyclone resistance as well as general repairs and maintenance especially Classroom Buildings 4 and 5 which require

complete replacement of the roof and roof structure and the wall framing, windows and doors.

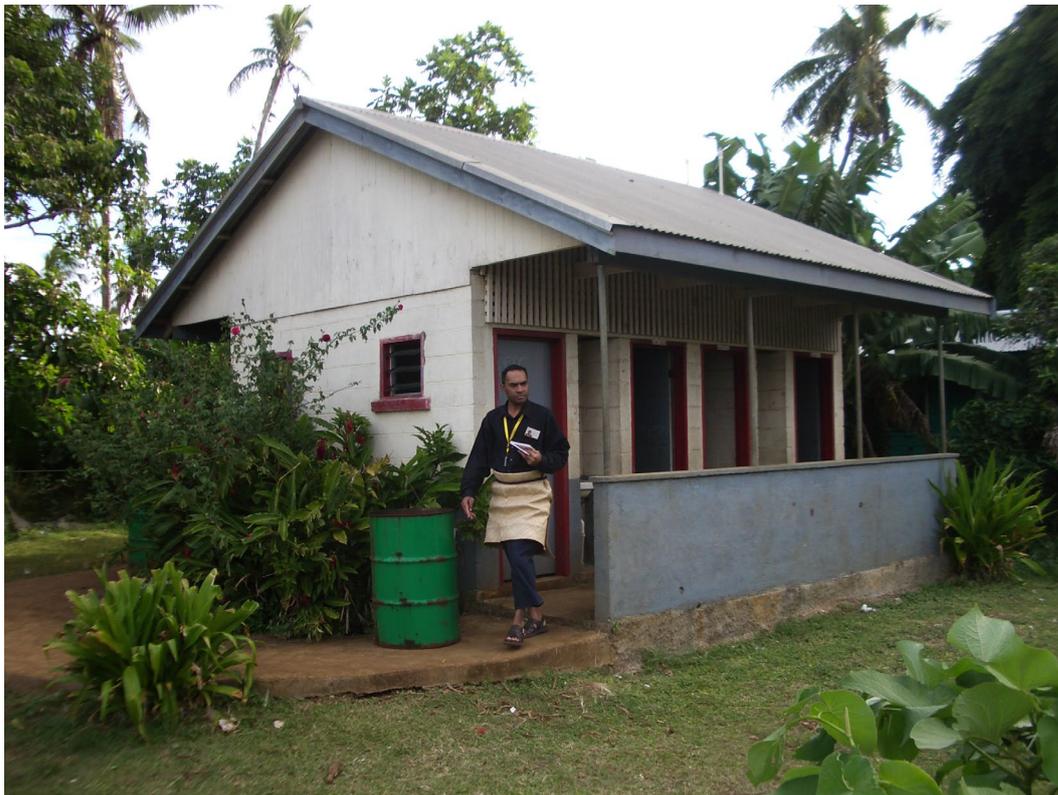
Plate 11: Toilet Building

Toilet Building: This building is fairly new and is the same standard design that was seen at the last school. It is constructed of fair-face blocks with a concrete floor, steel louvre carriers in timber frames, steel corrugated roof sheets on timber purlins and timber trusses. There are four WCs for girls and three WCs and a urinal for boys.

It seems well constructed but the roof sheets are fixed with nails not cyclone screws and washers. The trusses are well made but require additional cyclone fixings. Although there was a stand pipe with a water supply about 50 metres away the toilets do not have a water supply and they are very dirty and smelly. The two wash basins are both broken.

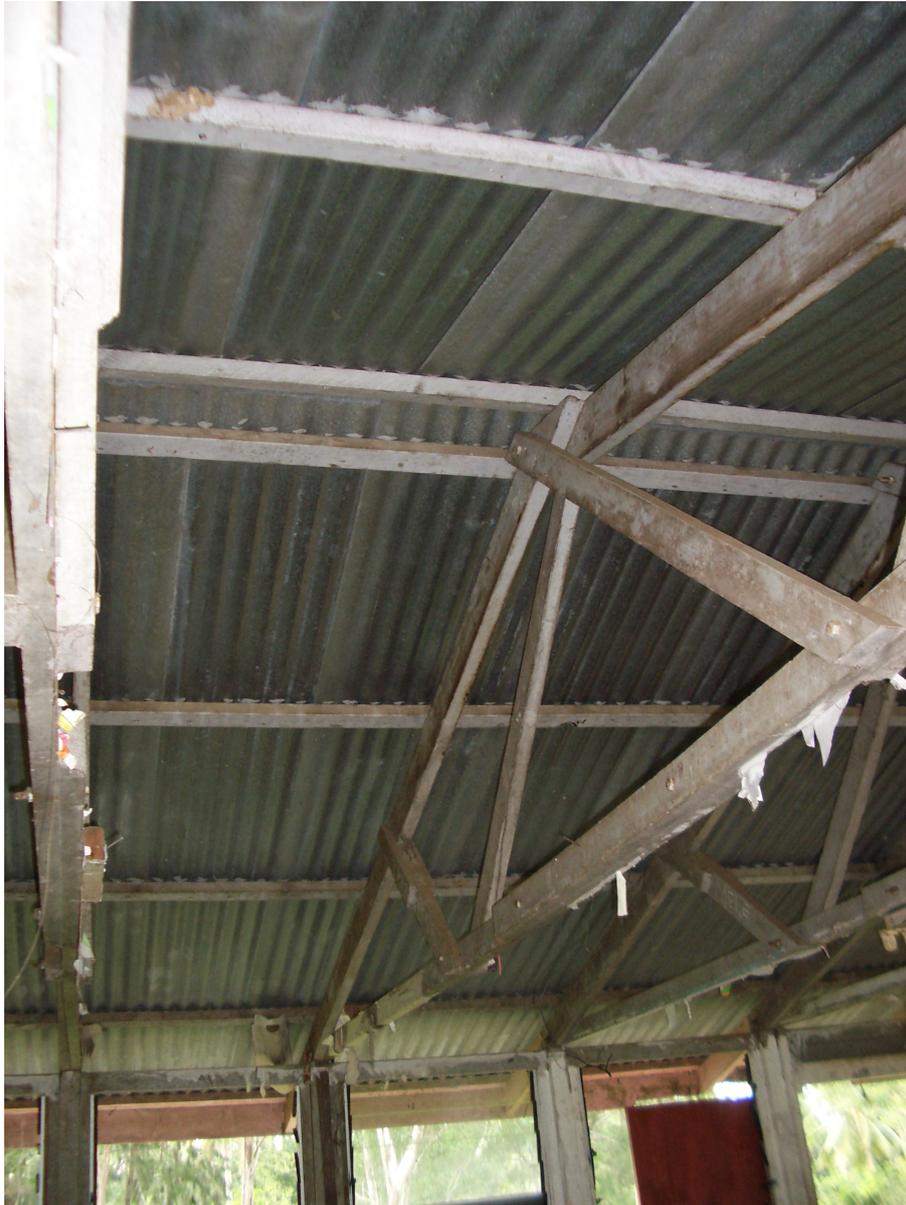
Plate 12: Inadequate bracing, purlin spacing and connections to roof timbers to Classroom Building 1

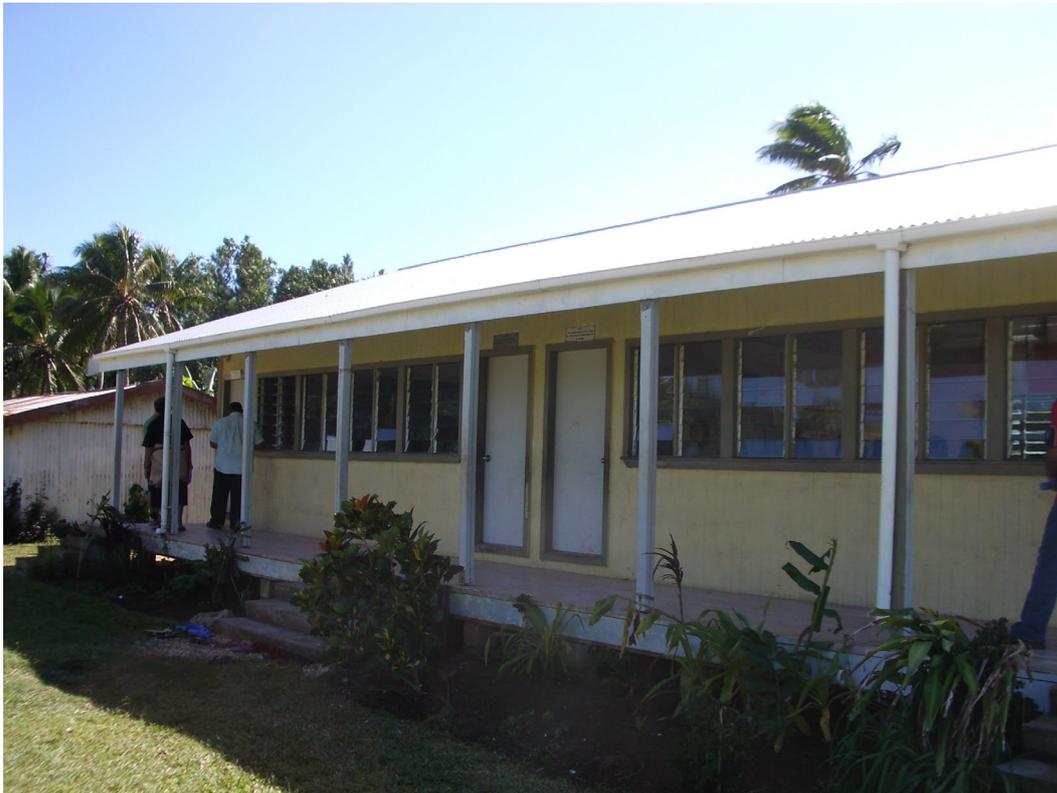
Plate 13: Classroom Building 1

The building seems quite well constructed (but it was not possible to see the roof trusses or how the walls are constructed) but the roof sheets are fixed with nails and not cyclone screws and washers and the block columns are not braced. The building needs painting and some louvre carriers need replacing.

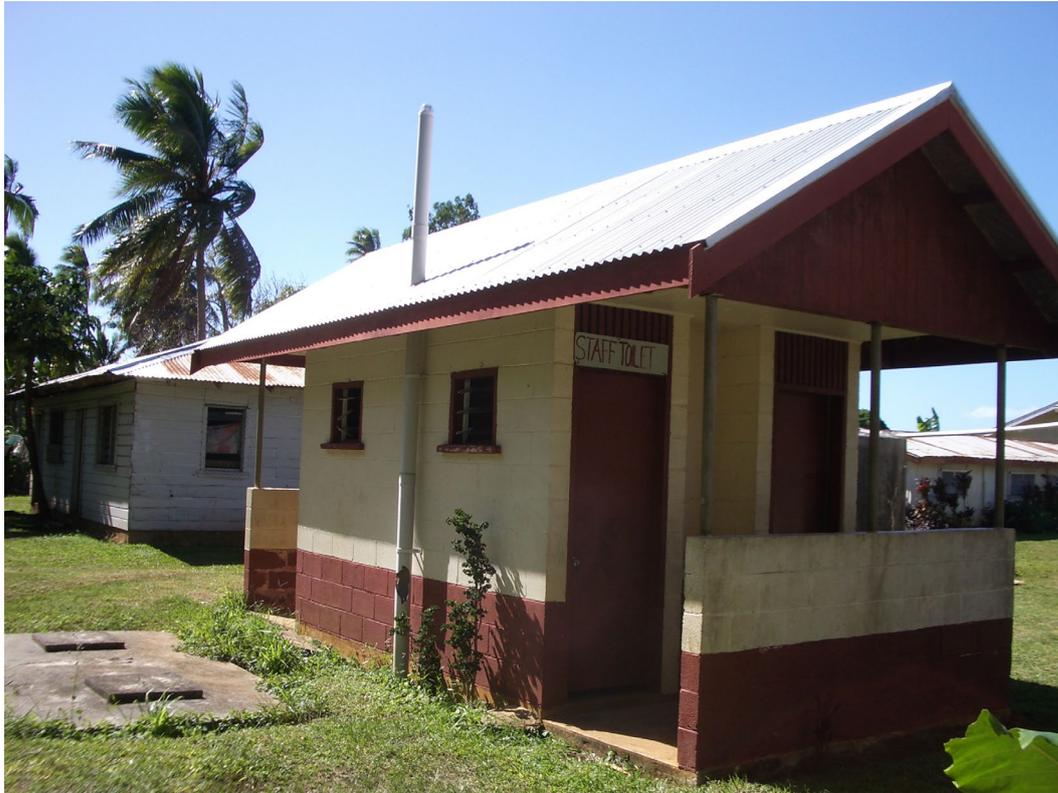
Plate 14: New Toilet Building with Staff House behind

It seems well constructed but the roof sheets are fixed with nails not cyclone screws and washers. The trusses are well made but require additional cyclone fixings especially to the purlins. The taps to the basins are loose but apart from that the toilets are clean and well looked after.

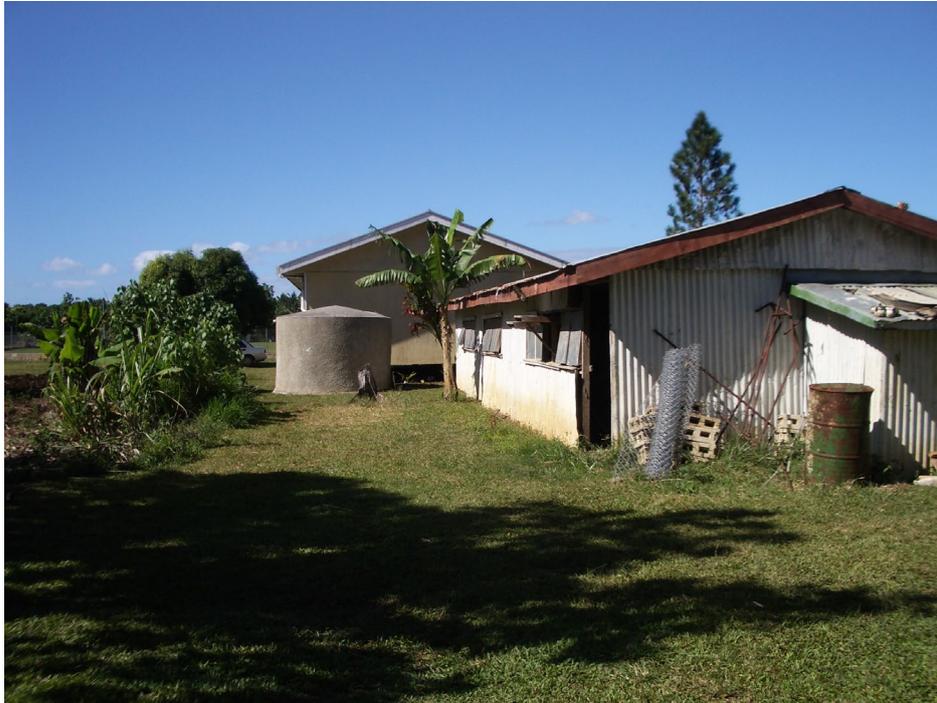
Assembly Hall: This is a temporary building constructed of timber framing with corrugated steel sheet walls and roof. It would not be economic to upgrade it but rather it should be demolished.

Plate 15: Assembly Hall

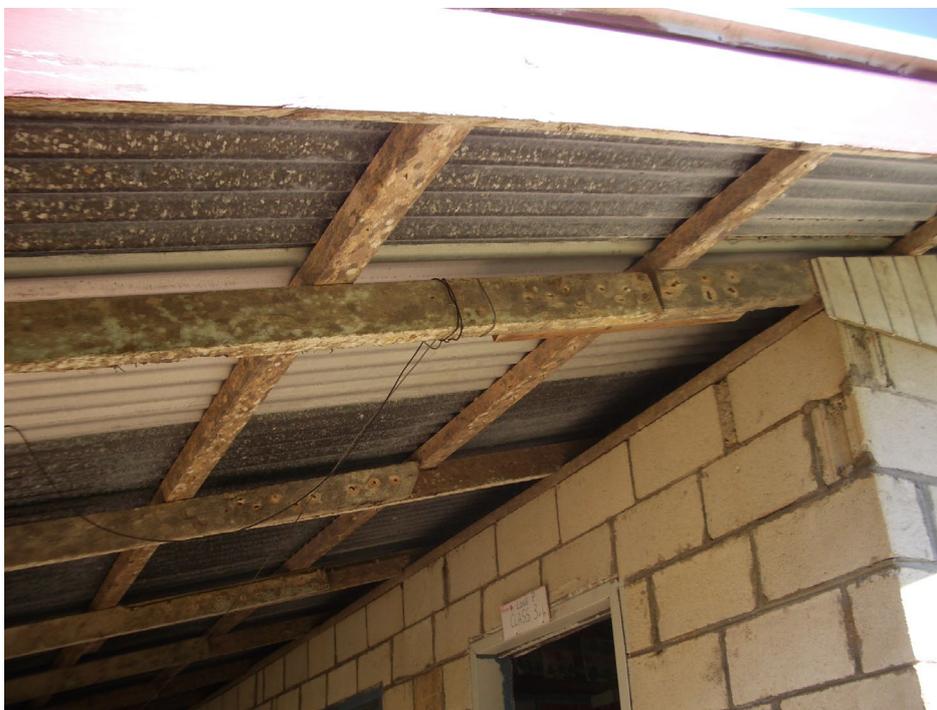
Plate 16: Inadequate roof structure and fixings to Classroom Building 2

Recommendations: The school requires additional facilities such as a store, an office/staffroom in order that all classrooms can be used efficiently. The old toilet building should be demolished and replaced together with Classroom Building 2 and the Assembly Building. Classroom Building 1 and the new toilets both need cyclone screws and washers to the roofs, cyclone fixings to purlins and trusses and other works such as bracing of the foundations and possibly bracing of walls.

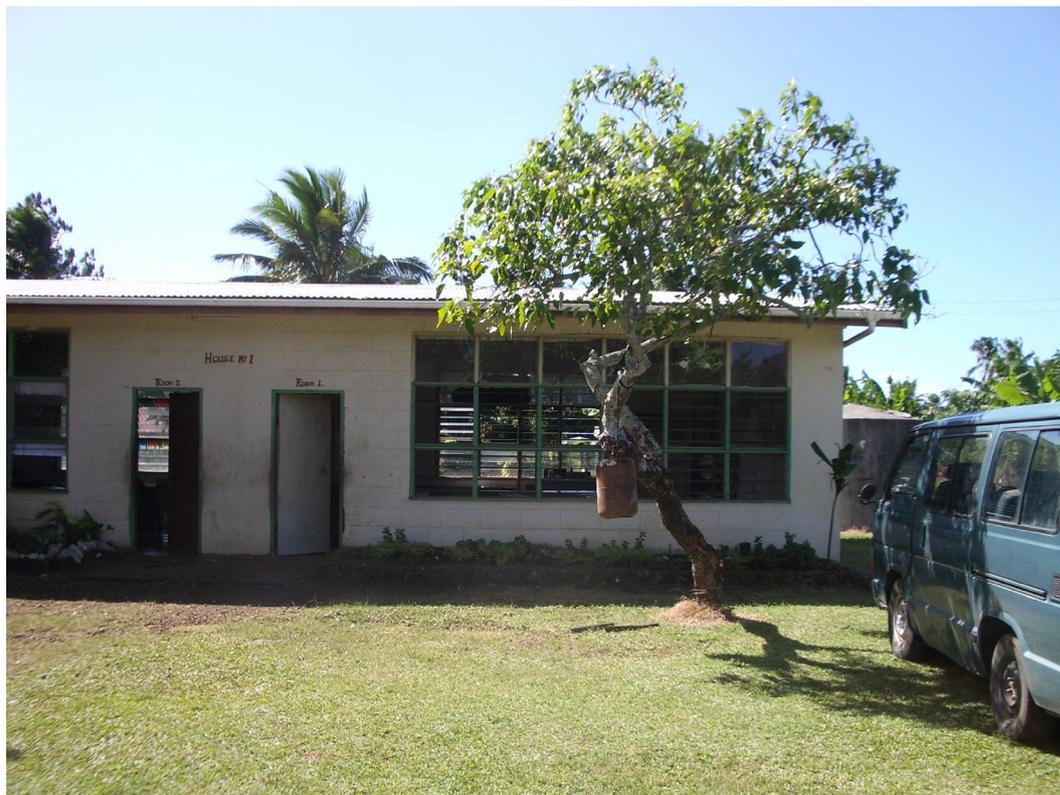
Plate 17: Classroom Building 1 showing large window area and lack of bracing in walls

The building was originally very well constructed but now needs major repairs and upgrading. The purlins are too far apart and so additional purlins are required together with cyclone screws and washers to the roof sheets; doors, louvre units and gutters need replacing and the classrooms need ceilings. The walls require additional bracing and the whole building requires painting.

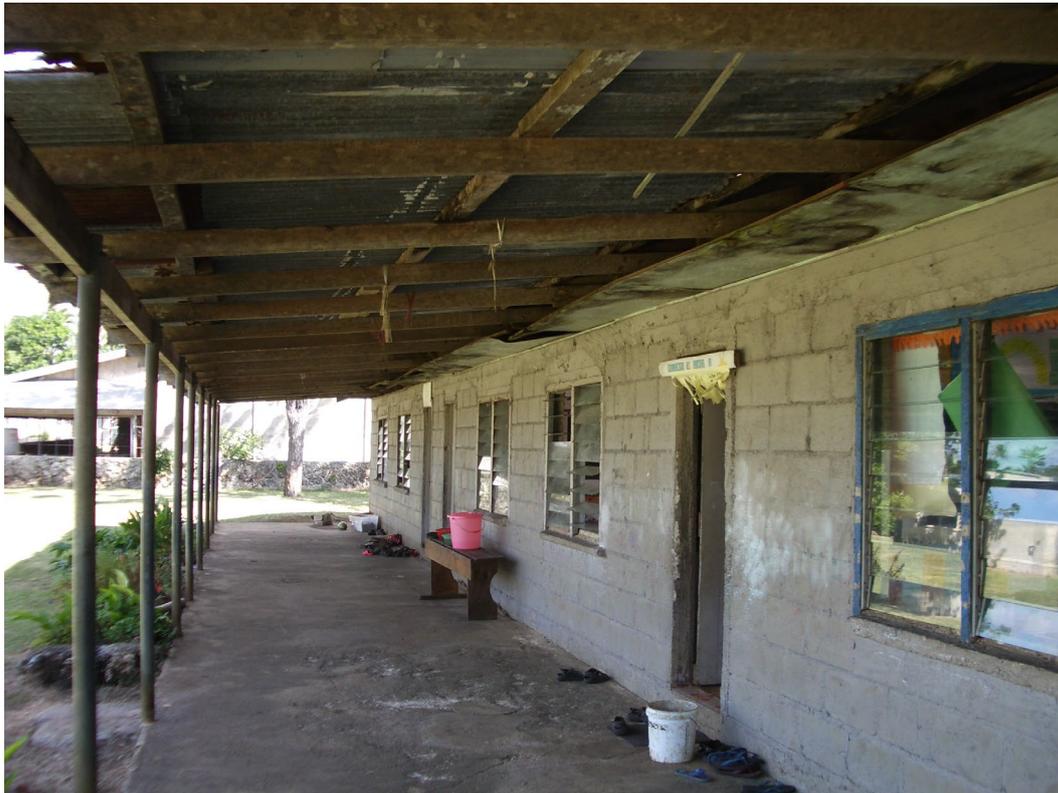
Plate 18: Rotting roof structure to veranda of Classroom Building 2

Classroom Building 2: This building was constructed by the PTA and has two small classrooms (7.4 x 4.7 metres wide), a small extension that is used as a library and a veranda. The building was very badly constructed initially and the roof is now in a very bad state with a lot of rotten members (the roofs over the library and veranda are particularly dangerous). The building should not be used and should be closed and demolished.

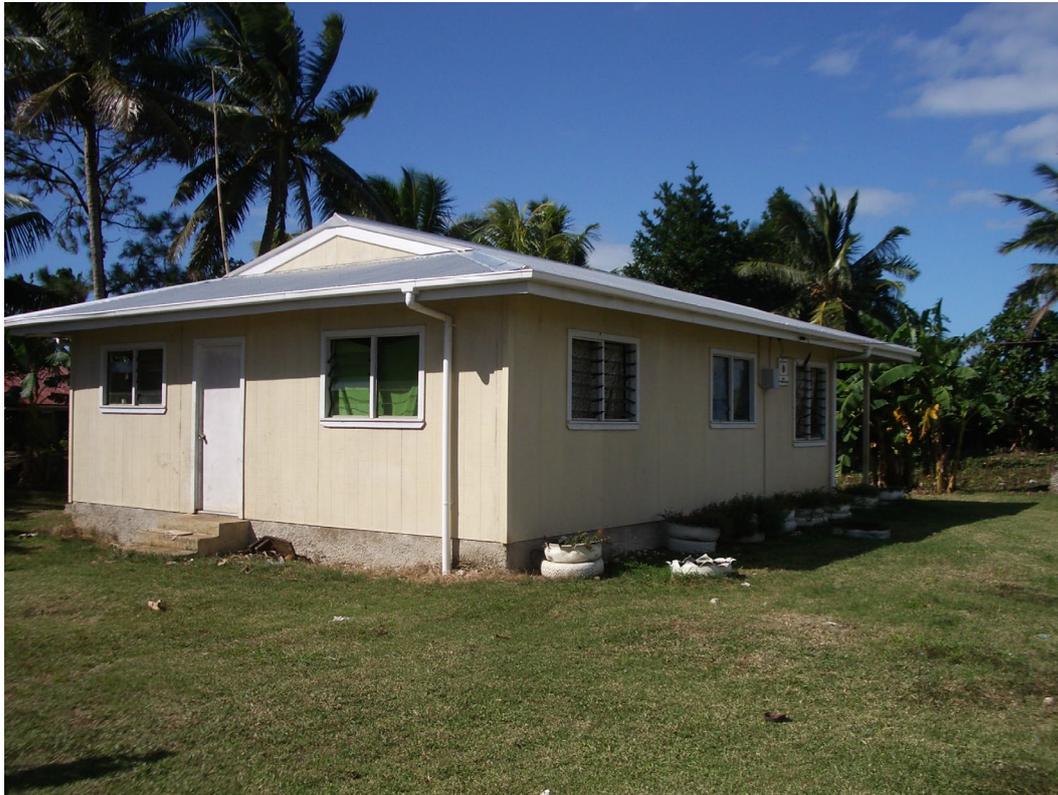
Plate 19: New Staff House

Staff House: This building was constructed last year to a standard MoW design using Japanese government funds. It was supervised by MoW architects. It has two bedrooms, a bathroom, kitchen and sitting room. It has a concrete floor, timber framed walls with plywood cladding, corrugated steel roof sheets on timber purlins and trusses, plastic louvre carriers in timber frames and masonite ceilings. The roof is hipped and there are a lot of roof leaks. The louvre windows are also leaking at the bottom (the roof overhangs are not large enough).

The building is quite well constructed but there are some problems. Roof sheets are fixed with nails not cyclone screws and washers and the tying down of the roof structure to the walls is totally inadequate. It was not possible to see how well the roof trusses are constructed or if the walls are properly braced and tied down to the foundations.

Recommendations: The school requires additional facilities such as a store, an office and a staffroom in order that all classrooms can be used efficiently. The old toilet building should be demolished and replaced together with Classroom Building 2 which should be closed immediately, demolished and replaced. Classroom Building 1, the new toilets and the Staff House need cyclone screws and washers to the roofs, cyclone fixings to purlins and

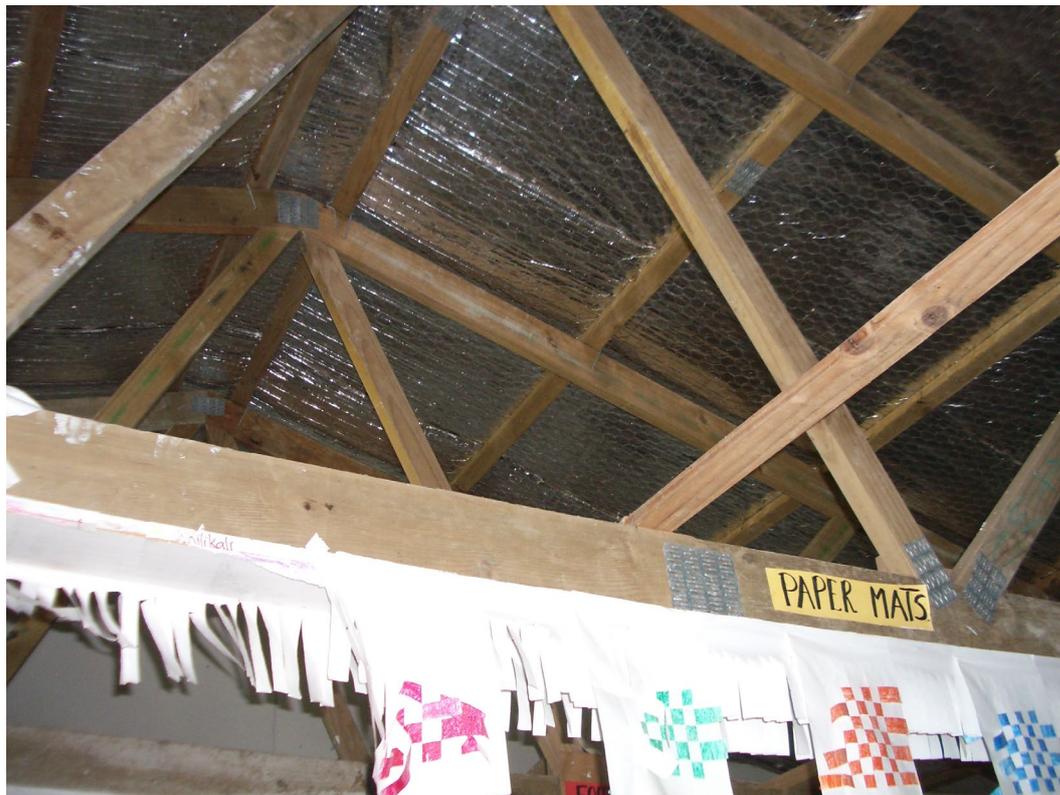
Plate 20: Inadequate fixings to roof timbers and wide spacing of purlins to Classroom Building 1

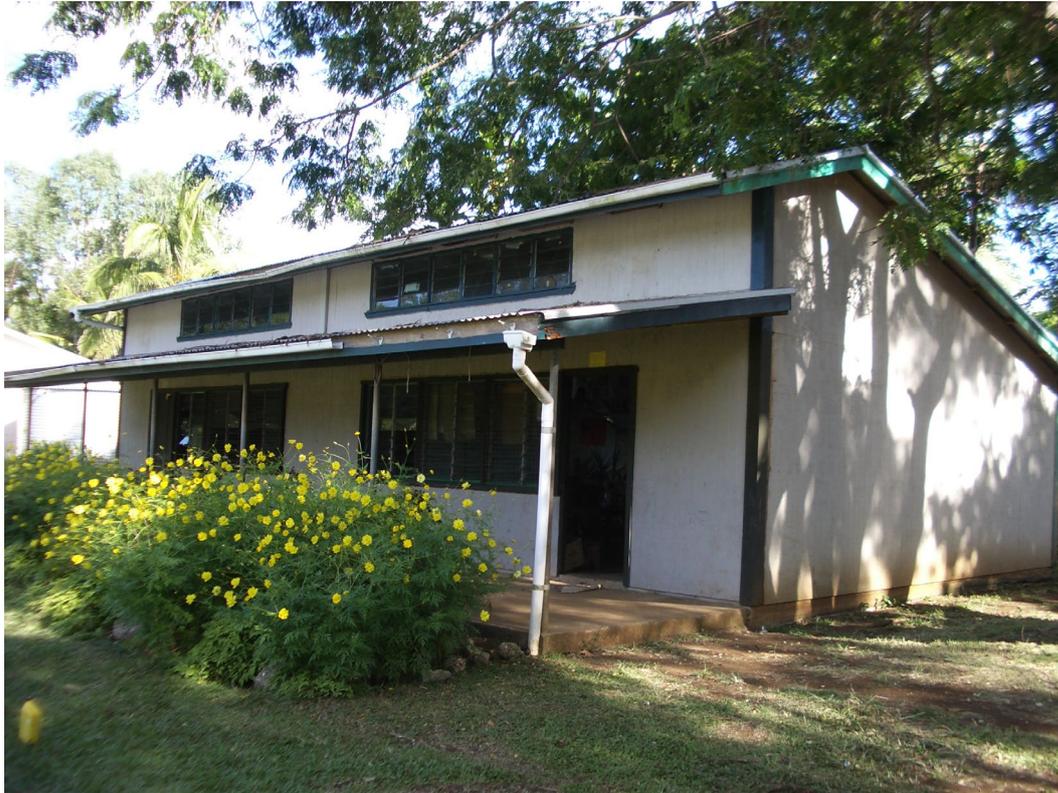
Plate 21: Classroom Building 1 showing close proximity of trees

The building was constructed by the Department for Natural Disasters in the 1980s and was quite well built. There are however a number of problems. The roof while being quite well constructed does not now meet the requirements of the new building code: the purlins are too small and too far apart, the joints to the trusses require reinforcement, the roof sheets require fixing with cyclone screws and washers, the trusses and purlins require cyclone fixings and the roof needs bracing. The opening between the classrooms should be closed off and braced, the other walls will also require bracing and it was not clear how well the timber framing is connected to the floor slab/foundation. The building also requires some other repairs and maintenance: repairs to the wall cladding; repair and replacement of louvre blades; painting and repairs or replacement of gutters. There is a bread fruit tree at the rear of the building that should be removed and the branches of another large tree overhanging the building should be cut back.

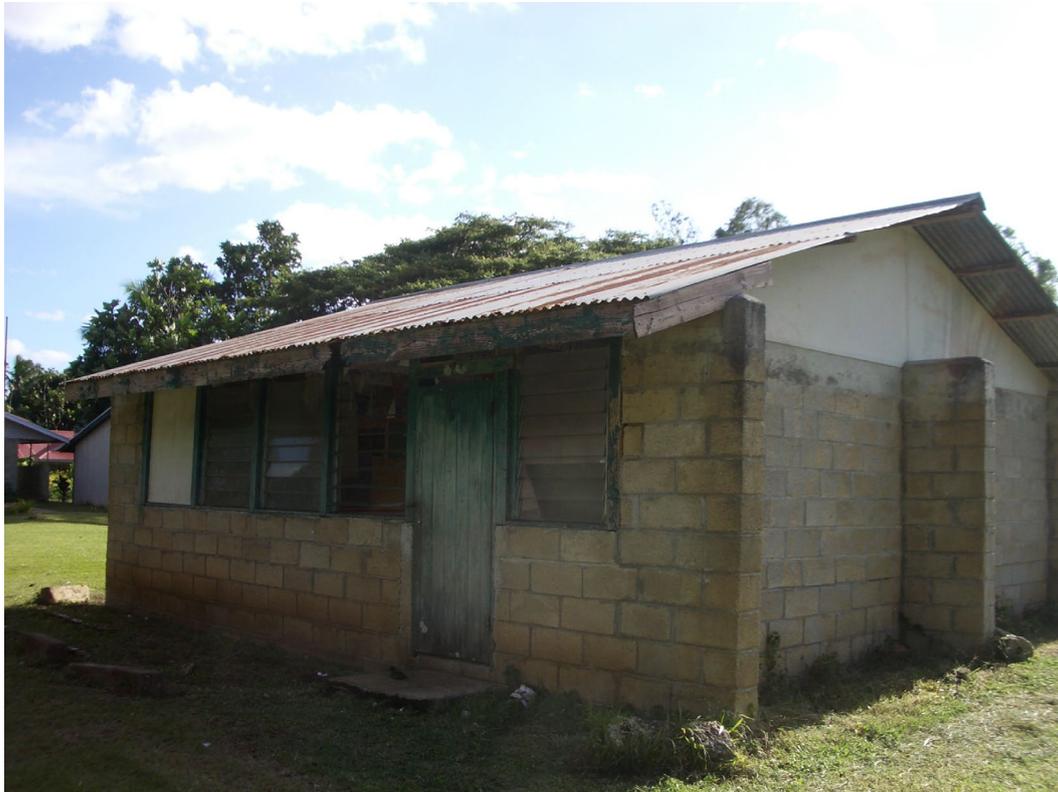
Plate 22: Classroom Building 3 that should be demolished

Classroom Building 3: This building has one classroom, is constructed in the middle of the playing field, is very badly constructed of concrete blocks and is in a very bad condition. It should be demolished and replaced.

Recommendations: The school requires additional facilities such as a store, an office/staffroom in order that all classrooms can be used efficiently. The old toilet building should be demolished together with Classroom Building 3 which should be replaced. The school also require one more classroom. Classroom Buildings 1 and 2, the new toilets and the Staff House need cyclone screws and washers to the roofs, cyclone fixings to purlins and trusses and other works listed above such as additional purlins and possibly bracing of walls.

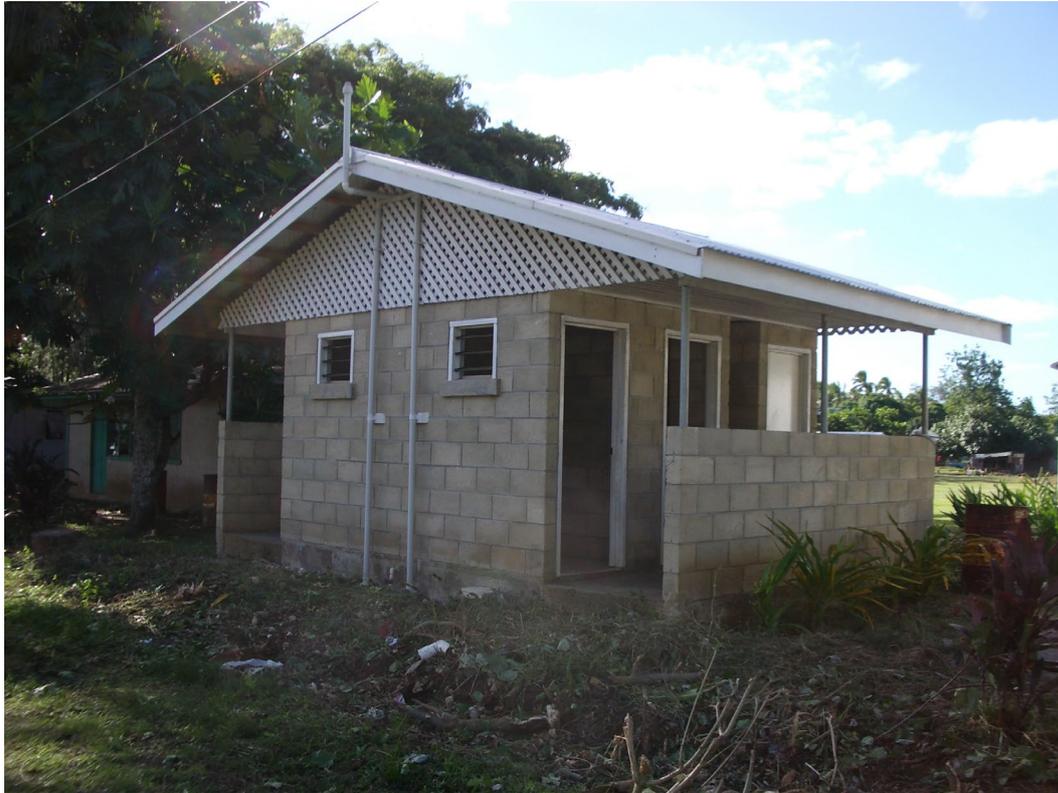
Plate 23: New Toilet Building

It seems well constructed but the roof sheets are fixed with nails not cyclone screws and washers and there are some cyclone fixings missing to the roof trusses and purlins. Two toilets are not working and there a bad leak in the boys toilets. Otherwise it is clean and in good condition.
