Tonga Education Support Programme

School Infrastructure Survey 2006

Infrastructure Advisor for School Mapping Report

June 2006

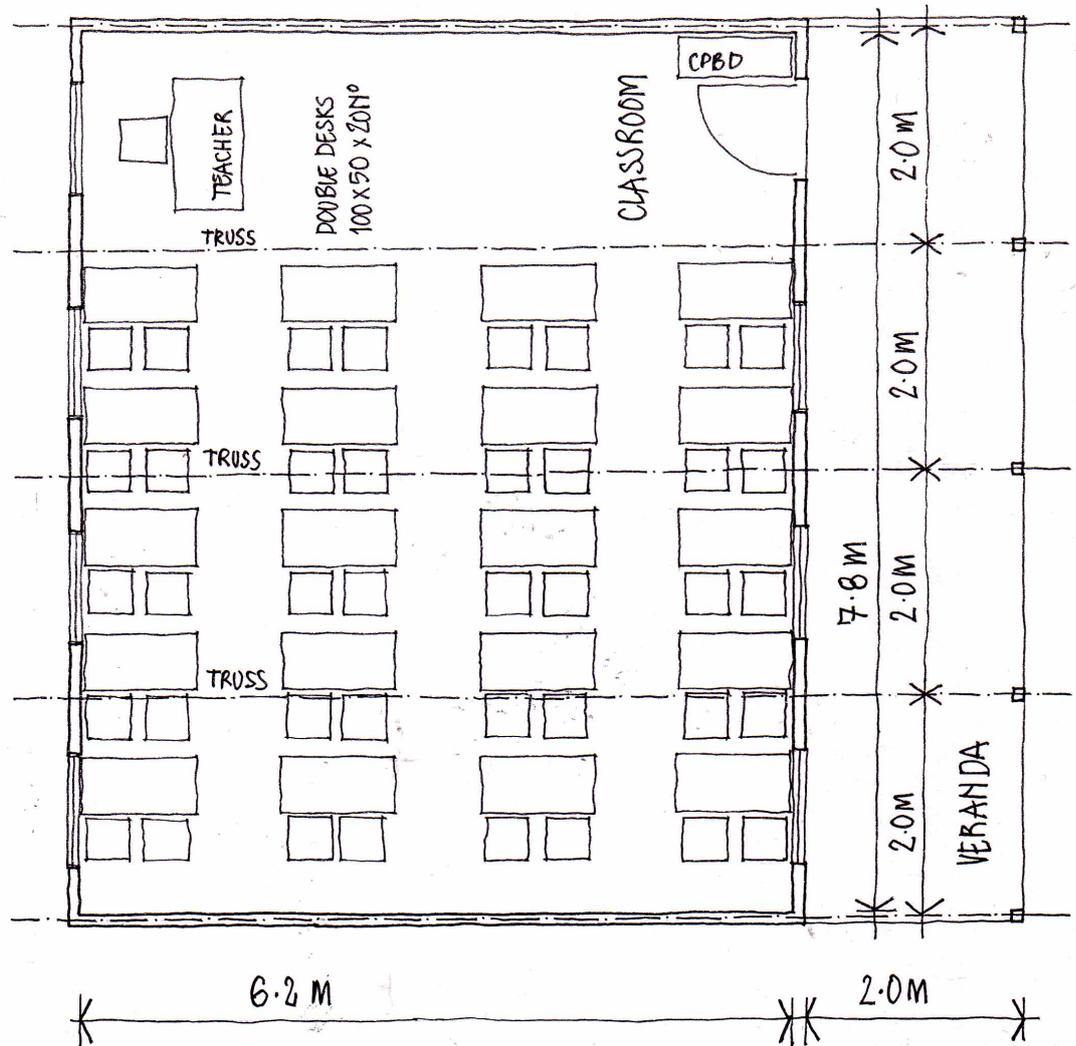
Drawing 1: Typical Primary School Classroom

A standard classroom size is proposed therefore that will accommodate between 30 and 40 students sitting at double desks with loose chairs. The proposed size is 7.8 long x 6.2 metres wide which gives a classroom area of 48.36M² and an area per student of 1.61M² with 30 students (similar to other Pacific countries) and 1.2M² with 40 students (similar to African and some S E Asian countries) which is still acceptable. See Drawing 1.
